# Ranikot Fort (Jamshoro, Sindh): An AMS Radiocarbon Date from Sann (Eastern) Gate

### Paolo Biagi and Renato Nisbet

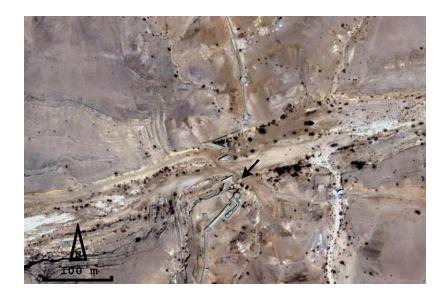
Fig. 1 - Ranikot Fort: satellite image of the Sann (Eastern) Gate with the location of the collapsed pillar (arrow) (*courtesy of F. Fuolega*).

The charcoal sample was included in an exposed horizontal layer of the Sann Gate pillar, some 1 m above the present-day course of Nai Sann torrent (BROHI, 1998: 45) (figs. 1 and 2).

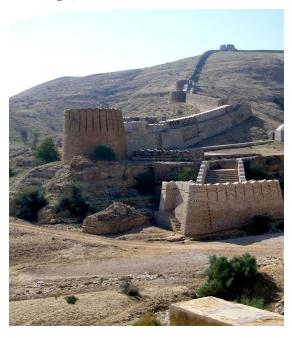
Fig. 2 - Ranikot Fort: the collapsed pillar at Sann (Eastern) Gate (photograph by P. Biagi).

The collapsed pillar, as it is visible today, has a rectangular section with rounded corners, sides of 8.50 and 4.50m respectively, and a height of some 4.40m. Its upper part consists of the original limestone bedrock, on which the pillar itself has been erected (fig. 3). The detachment niche is still visible on the cliff, ca. 10m above the river bed. The stone bricks are of a different sizes, regularly laid in the inner part of the pillar, and perfectly arranged on its surface.

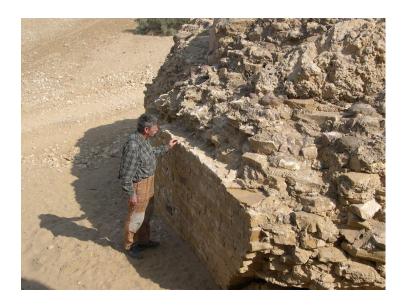
Fig. 3 - Ranikot Fort: the surface from which the charcoal sample was collected (*photograph by P. Biagi*)

The presence of a few charcoal fragments in the mortar of the collapsed pillar (figs. 3 and 4) could be explained, as a result of 1) the process of lime production in kilns, or 2) their accidental inclusion during the preparation of the plaster used to stick the bricks. In both cases, the charcoal dates some operations that probably occurred just before the erection of the pillar.

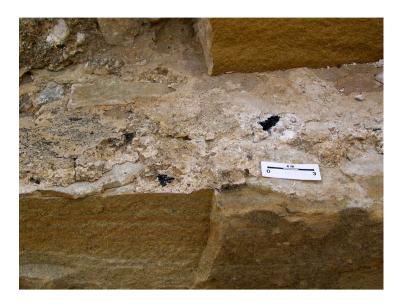
Fig. 4 - Ranikot Fort: *Acacia* charcoal fragments *in situ* in the pillar's exposed surface (*photograph by P. Biagi*)

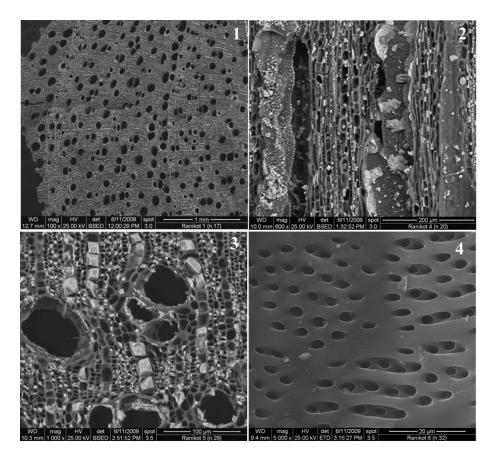
Fig. 5 - Ranikot Fort: *Acacia* charcoal. 1) Transverse plane, diffuse pores; 2) tangential plane, uni- and biseriate rays; 3) transverse plane, crystalliferous parenchyma cells surrounding the pores; 4) radial plane, vessel pits (*SEM photographs by R. Nisbet*).

Seven fragments of charcoal included into the mortar, or plaster, amongst the bricks of the wall were analysed at SEM in order to identify the tree species and their possible ecological provenance. Their main anatomical characteristics are (fig. 5): growth rings usually discernible diffuse wood, pores rounded or slightly oval, isolated or in short (3-4) radial chains, paratracheal parenchyma, with abundant crystalliferous cells. Rays 1 to 3(4)-seriate, homogeneous; vessel pits mostly elliptical.

All fragments show the anatomy of *Acacia* sp. but, out of more than 30 species and subspecies growing today in Pakistan (ALI, 2008) no attempt to determine a lower taxonomical level has been made, due to the absence of a complete reference collection.

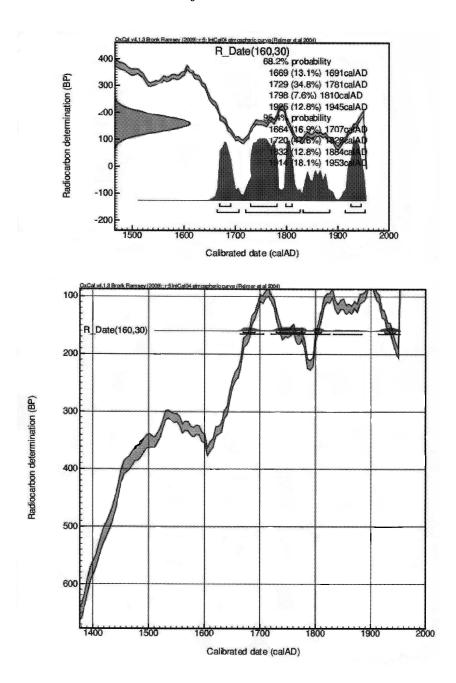
Fig. 6 - Ranikot Fort: radiocarbon and calibrated results of sample GrA-44671 (*courtesy of T. Fantuzzi*).

An *Acacia* charcoal sample collected from the above exposed surface was sent to Groningen Radiocarbon Laboratory (NL) for AMS dating. It yielded the following result 160±30 uncal BP (GrA-44671). Although its calibration is rather problematic, given that the curve at this point is highly fluctuating with several interceptions, most probabilities indicate that the pillar was erected between cal AD 1720 and 1828 (47.6% at 2 sigmas, according to OxCal 4.10: BRONK RAMSEY, 2009), although another interception suggests a much more recent date (fig. 6).
